Technical Investigation Report concerning the Fire on Eurotunnel Freight Shuttle 7412 on 11 september 2008

**Bureau d'enquêtes sur les
accidents de transport
terrestre**

**Rail Accident
Investigation Branch**

**Technical Investigation Report
concerning the Fire on
Eurotunnel Freight Shuttle 7412
on 11 September 2008**

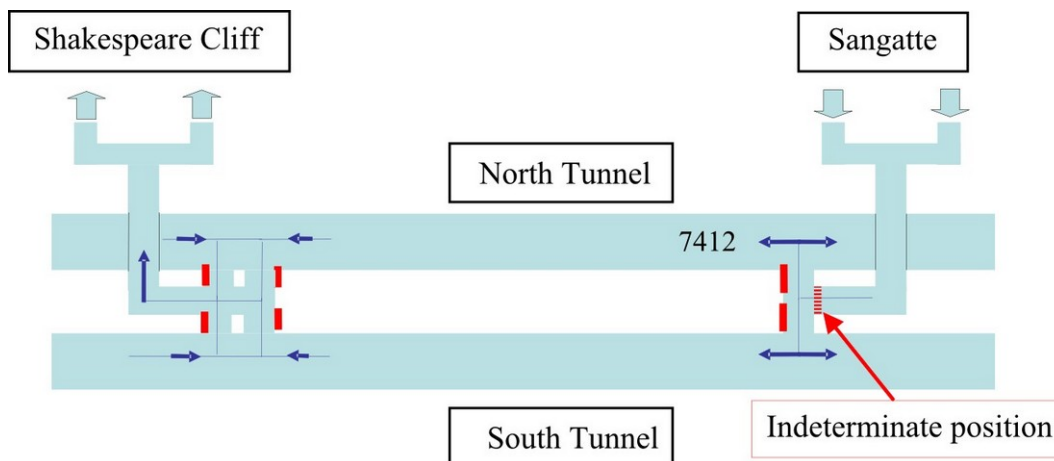
A malfunction in the main French damper is signalled at that time. The controller therefore concludes, as his instructions specify, that this damper is still closed and that there is no ventilation being provided on the French side¹⁷. To compensate for this assumed fault, he decides to have the two Shakespeare Cliff fans working in extraction mode in the North Tunnel only.

¹⁷ (it should be noted that the EMS controller does not think of checking the information on the rate of air being blown in on the French side. Had he done so, he would have noticed that the rate was normal and could have concluded that the main damper was open.)

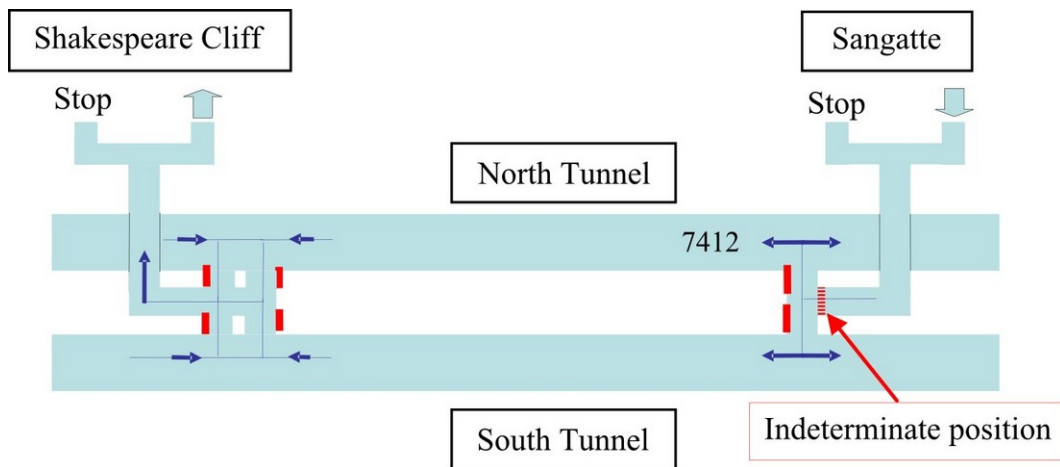
At 16:09'17'' a fan on the French side breaks down following the failure of the 21 kV cable. As the damper supplying the South Tunnel at Sangatte is still open, there is reduced air flow in the North tunnel.

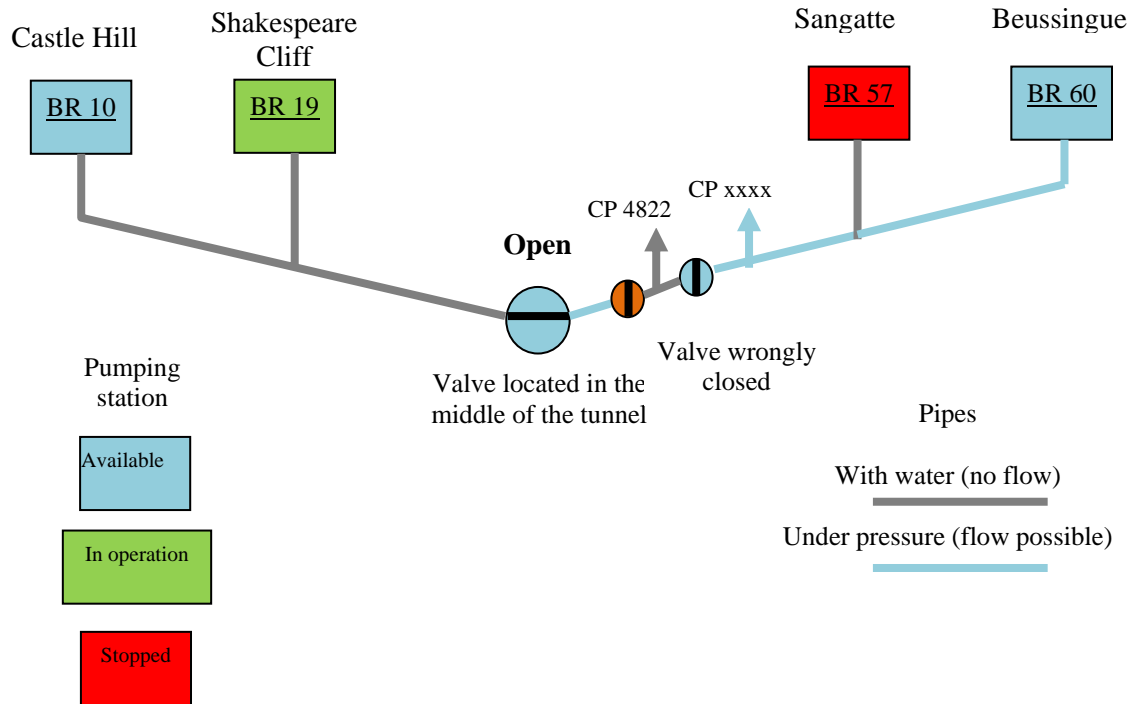
Figure 31: Loss of water supply at cross-passage 4822 between 19:01 hrs and 19:35 hrs

The diagram below shows the situation of the water system at 19:01 hrs and 19:35 hrs.

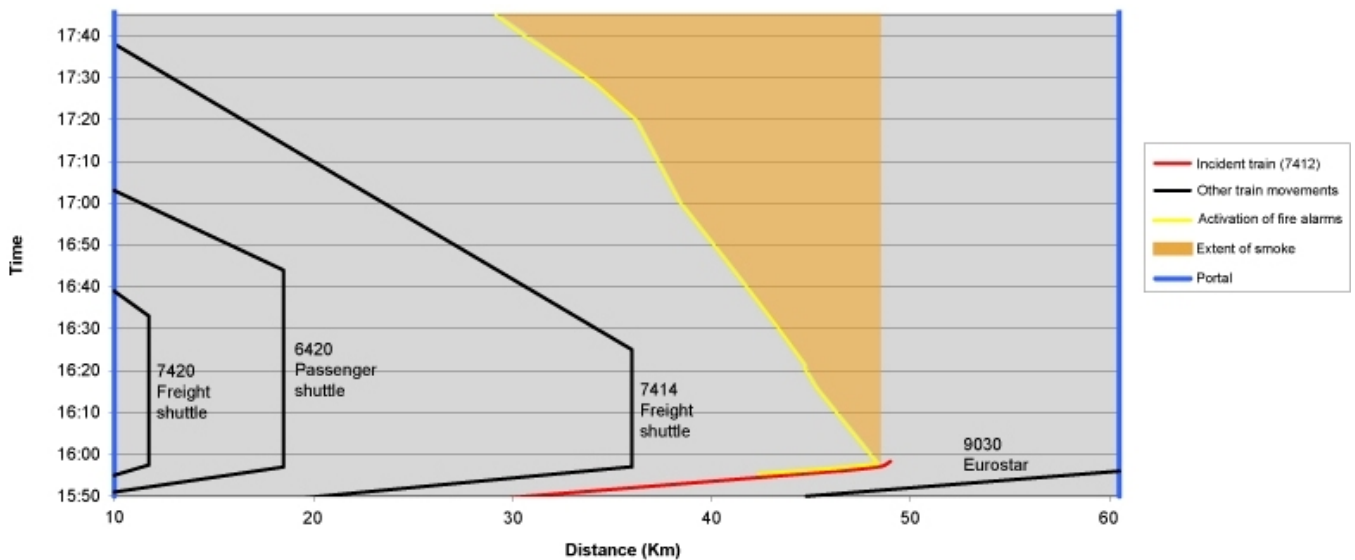
Figure 33: Spread of smoke in the Running Tunnel North

After 16:03 hrs, the smoke is pushed back towards the UK portal. It moves at a speed in the order of 2.7 metres per second. It reaches the point at which mission 7414 stopped approximately forty-five minutes after that mission started to return towards the UK. The differences are even greater with the two other missions in the same tunnel that have had to return.

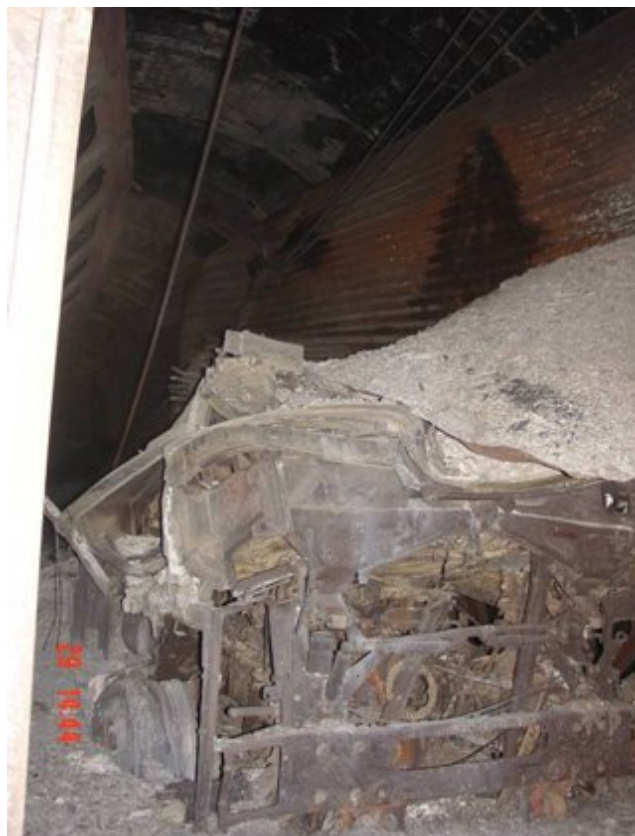
Figure 34: Damage suffered by one of the carrier wagons and its load

However, once it had stopped, the loaded carrier wagons suffered significant damage. For the most part, the side walls and the roofs were deformed by the heat of the fire and by debris falling from the roof of the tunnel.

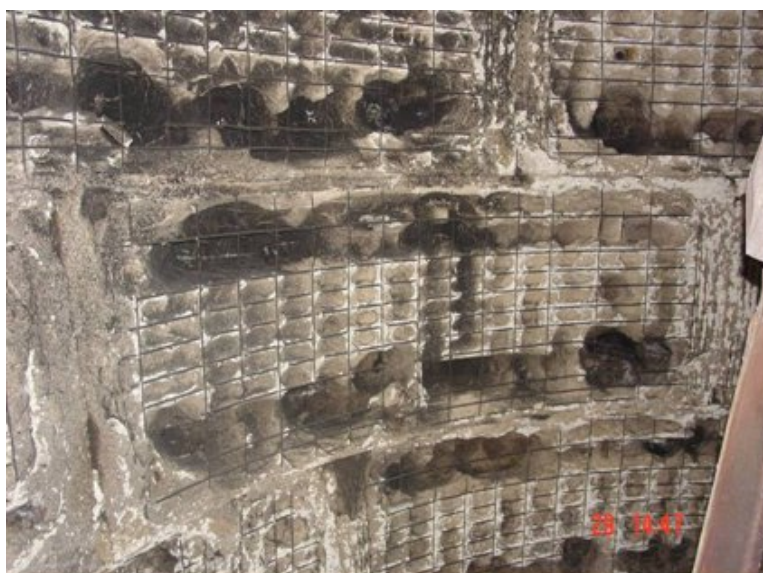
Figure 35: Damage suffered by the tunnel lining at the level of the tunnel roof

The equipment fastened in the area of the fire was destroyed.

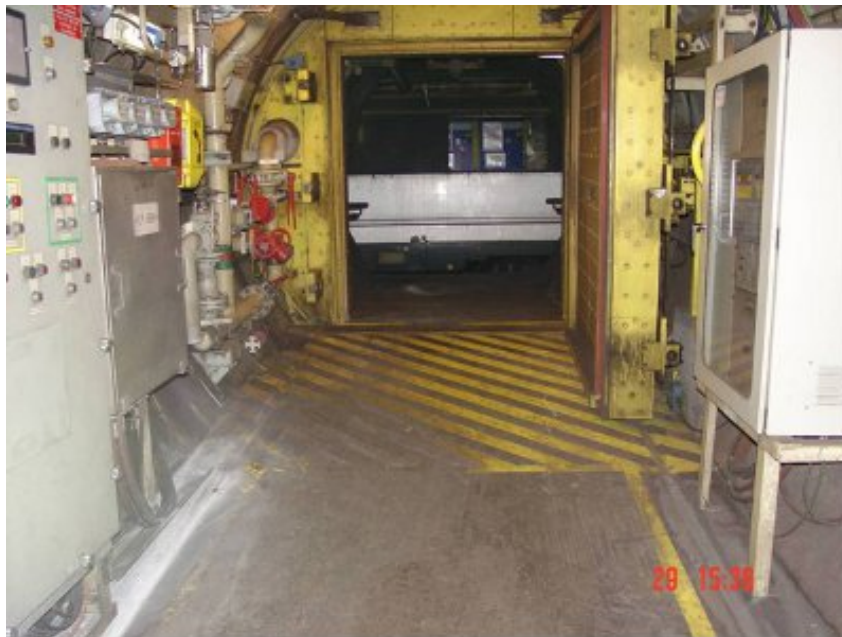
Figure 40: View of the amenity coach from the service tunnel through cross-passage 4898 (showing the window through which the majority of the passengers left)

Also, the window beside the cross-passage is broken by the passengers and used by 25 passengers and the member of the catering staff.
