Bureau d'Enquêtes sur les Accidents  
de Transport Terrestre

# ANNUAL REPORT 2016

Land Transport Accidents Investigation Board (BEA-TT)  
Grande Arche – Paroi Sud  
92055 La Défense cedex  
Tél : 33 (0)1 40 81 21 83 – Fax : 33 (0)1 40 81 21 50  
email: [Bea-tt@developpement-durable.gouv.fr](mailto:Bea-tt@developpement-durable.gouv.fr)  
web : <http://www.bea-tt.developpement-durable.gouv.fr>

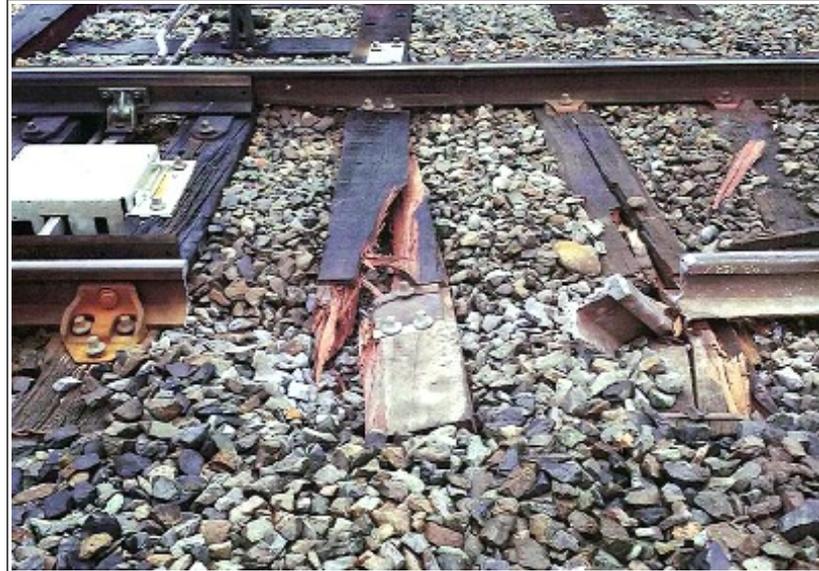
#### Multiple fracture of rail passed at high speed by trains on 23 November 2013 at Carbonne (31)

At 06:03 on 26 November 2013, a rail fractured when a train passed the 39+129 km mark on the right-hand rail of track 1 on the Toulouse to Tarbes line. This caused a train warning bell to malfunction. It began to ring continuously at the station at Carbonne.

At 09:50 the signal maintenance agent who had been trying to find the cause of the malfunction of the warning bell since 08:05 discovered a gap of about 1.30 m which, as it turned out, had been passed at 150 km/hour by inter-city train No. 14241.

This event, which could have been extremely serious but only led to limited material consequences, was due to three direct causes:

- multiple failure of the rail linked to the presence of three fragile points on the rail within a short distance and a fault in the track geometry;
- lack of any prescription for safety measures in the event a warning device malfunctions;
- a delay in detecting the rail failure, as the track was not equipped with track circuits linked to the signalling system.

- monitoring and eliminating half switch points where the flange is machined in an obsolete manner, resulting in an angular point;
- detection of rail failures by track circuits not linked to safety installations;
- detection of rail failures by train drivers.

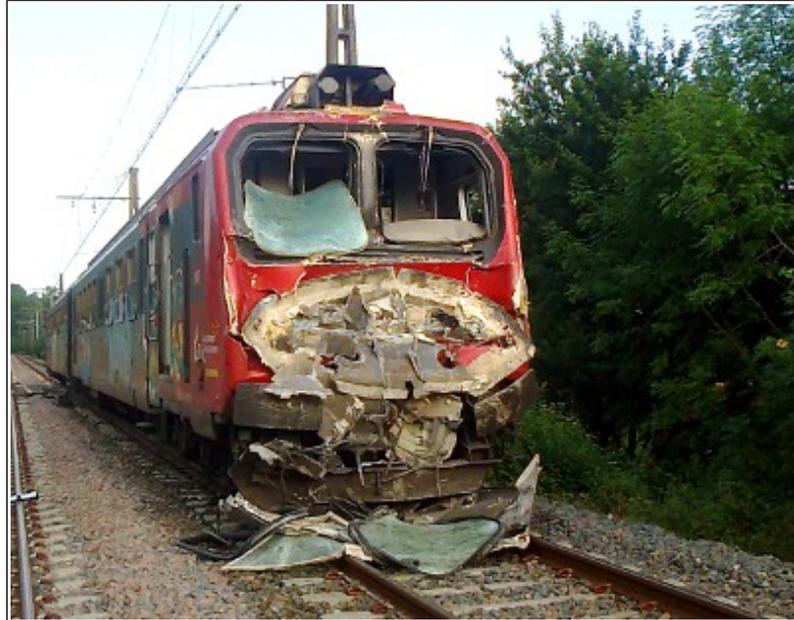
## Catch-up collision between two passenger trains on 17 July 2014 at Denguin (64)

At about 17:30 on 17 July 2014 in the Denguin municipality in the Pyrénées-Atlantiques department, regional express train No. 867285 travelling going towards Dax on the railway line connecting this town to Tarbes caught up with TGV high-speed train No. 8585 and collided with it at a speed of 95 km/h.

The direct cause of this accident was the fact that signal S 23 incorrectly showed a green light while the next section was still occupied by TGV No. 8585.

- the design and construction of the signal box did not provide sufficient protection against the entry of rodents on the one hand and the fact that the cables were not easily visible due to the layout of the signal box. In addition, the fact that the different electrical circuits were not separated made it impossible to avoid possible contact between conductors that could lead to dangerous faults;
- during maintenance operations, the damage that could be caused by rodents to electrical cables in signal boxes was not taken sufficiently into account.

- the first recommendation concerned signal box design;
- the second recommendation was to improve prevention of risks due to the entry of rodents into these facilities during preventive and remedial maintenance operations.

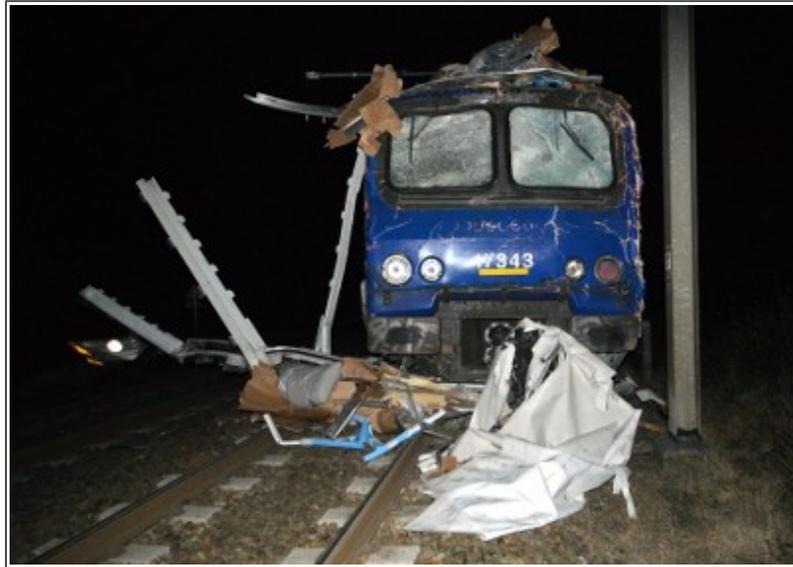
**Collision between a regional express train and a lorry  
on 9 December 2014  
at LC No. 169  
at Montauban (82)**

At 18:13 9 December 2014, regional express train No. 871833 travelling on railway line 640000 from Bordeaux-Saint-Jean to Sète-Ville and providing the service from Agen to Toulouse-Matabiau collided with a lorry on level crossing No. 169 mentioned above located in the municipality of Montauban, which allows road vehicles travelling on the Chemin du Quart to cross the railway lines.

The direct and immediate cause of the accident was the fact that two heavy goods vehicles crossed on level crossing No. 169, which was too narrow and prevented the lorry hit by the train from moving. The other lorry involved managed to move clear of the level crossing before the train arrived.

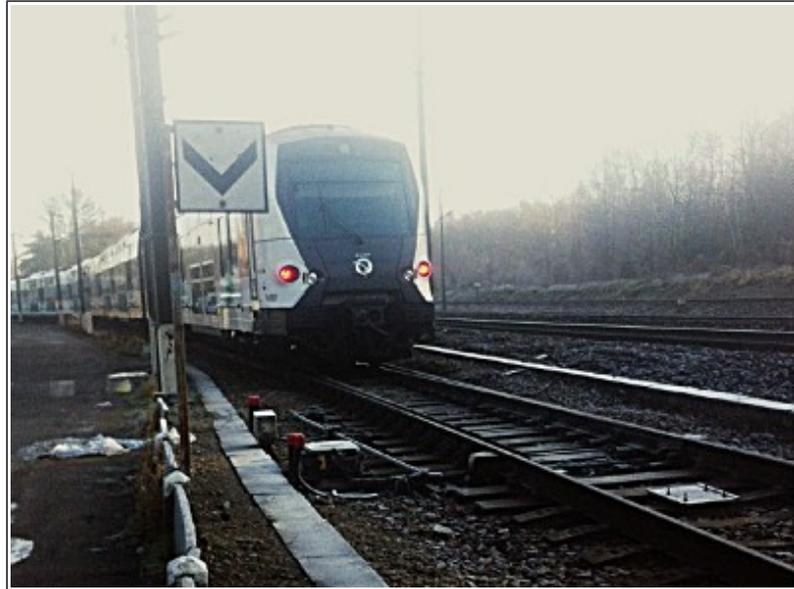
**Accidental diversion of a suburban RER A train  
into sidings  
on 9 December 2014  
at Saint-Germain-en-Laye (78)**

At 06:12 on 9 December 2014 near Achères-Grand-Cormier station in the municipality of Saint-Germain-en-Laye in Yvelines, a suburban RER A train travelling on the 2bis line going towards Paris passed switch points 116 at 87 km/h where the speed limit is 30 km/h and was diverted to the sidings without the signals giving any notification. Fortunately the train did not derail and did not collide with any other rolling stock in the sidings. There were no casualties.

The direct cause of the incident was a wiring fault in the four electric control system cables for switch points 116 which occurred in the course of works to replace a signal cable with 28 pairs of conductors connecting the service room of signal post A to a signal box near these switch points. On conclusion of these works, the position of the switch points on the ground was reversed in relation to its control system and controls at the A signal post at Achères.

- on the one hand in a reversal of the terminals in the technical diagram describing the available cable ends in the signal box mentioned above, probably from when the facility was first installed. These wiring replacement works were carried out according to this inaccurate diagram and the error was neither detected during their preparation nor in the course of technical checks and tests;

- the quality of training and supervision of young inexperienced agents who manage maintenance and works on signalling installations;
- the legibility of SNCF specifications for work on safety installations;
- the quality of the compliant diagrams of the safety installations;
- the quality of test programs for small-scale works on safety installations.

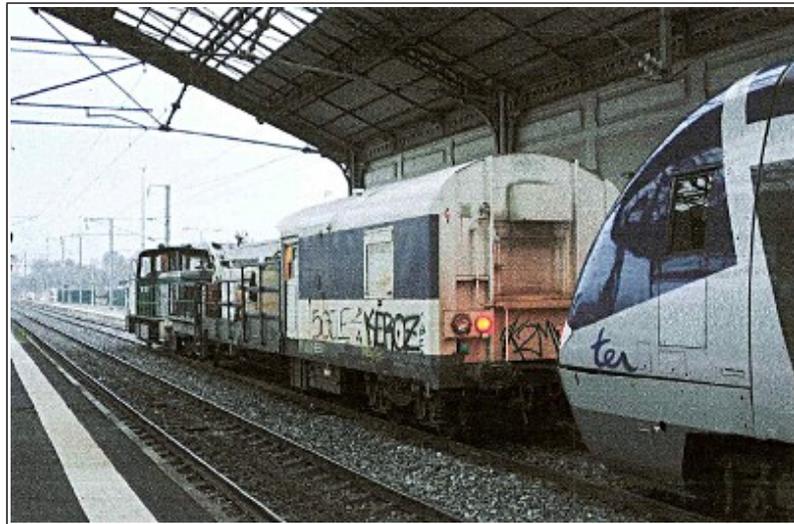
**Impact between a Regional Express Train stopped at a platform  
and an infrastructure inspection train  
which occurred on 15 December 2014  
in the station at Saint-Germain-des-Fossés (03)**

At 08:37 on 15 December 2014 at Saint-Germain-des-Fossés station in the Allier Department, after moving about 500 metres at an estimated speed of 18 km/h, infrastructure inspection train No. 819 070 collided with regional express train No. 873 355 which was standing at the platform on the second part of track A awaiting departure to Vichy at 08:38.

The direct cause of the accident was the decision of the driver of the infrastructure inspection train to carry out a shunting manoeuvre without visibility in the direction of the main lines without being guided by a movement controller. In fact he therefore contravened the regulatory procedures and above all simple safety logic.

- improving the reliability of the operational system for monitoring SNCF Réseau drivers to improve the detection and correction of incorrect behavior;
- recording all operational conversations from the service telephones of signallers.

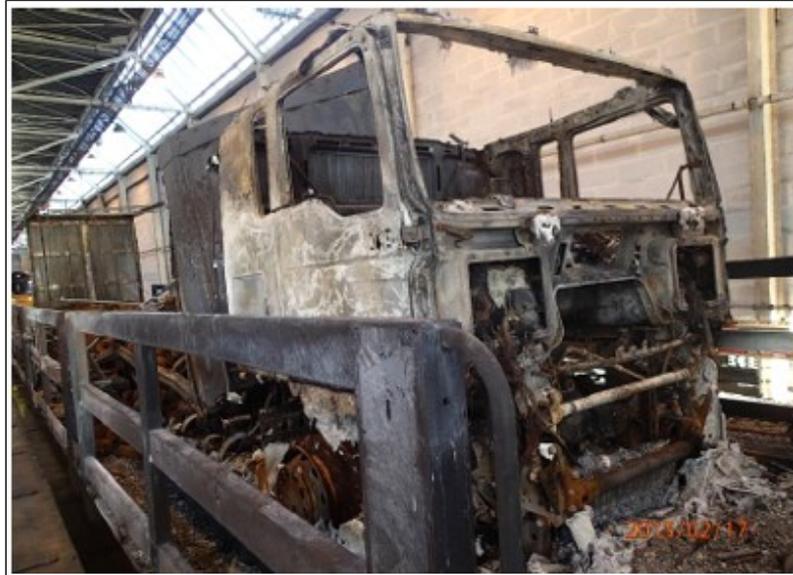
## Fire on board Eurotunnel freight shuttle 7340 on 17 January 2015

At 11:57 on 17 January 2015 Eurotunnel freight shuttle 7340 left the English terminal at Folkestone loaded with 30 vehicles. This shuttle was of the Arbel type on which the Front train section has no roofs.

As the train was entering the tunnel at 12:00, following an electric arc with the catenary, the shuttle stopped due to a power cut in the catenary. After the power was restored, the train set off again at 12:03. At about 12:23, when the train was about 1 km before the firefighting station (SAFE 4F), a fire was detected on board the shuttle.

The two lorries located on wagons Nos. 14 and 15 in the front train section burned out completely.

The North rail tunnel was damaged. In addition to the failed catenary and electrical wiring, the reinforced concrete of the vault was damaged by the fire. The rendering came off over about 60 m, leaving the reinforcing steel visible in the lining.

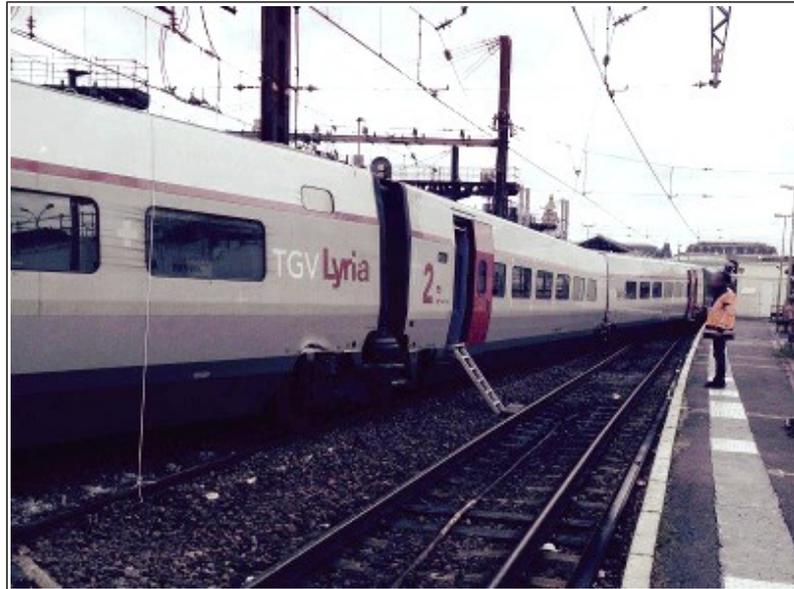
## Train derailment on 28 January 2015 at Paris Gare-de-Lyon

At 17:35 on 28 January 2015 a train composed of two empty TGV sections derailed at a speed of 29 km/h just after the 22L switch points at Paris Gare-de-Lyon. It was proceeding from the washing depot to join line 15 at the platform from which it was to leave at 18:23 for Zurich. The train stopped about 240 metres further down the line. There were no casualties, but the rolling stock and track facilities were badly damaged.

The direct cause of the accident was a change of position of switch points 22L under the third carriage of the front train section. The first part of the train was directed as planned towards track 15 at the platform, while the second part was diverted by the switch points towards track 7. This caused four intermediate carriages to derail and end up across tracks 7 to 15.

- the quality of practical training and supervision of young SE personnel;
- the quality of local specifications for the maintenance of old and unconventional safety installations;
- the installations at Signal Posts 1 and 2 at Paris Gare-de-Lyon.

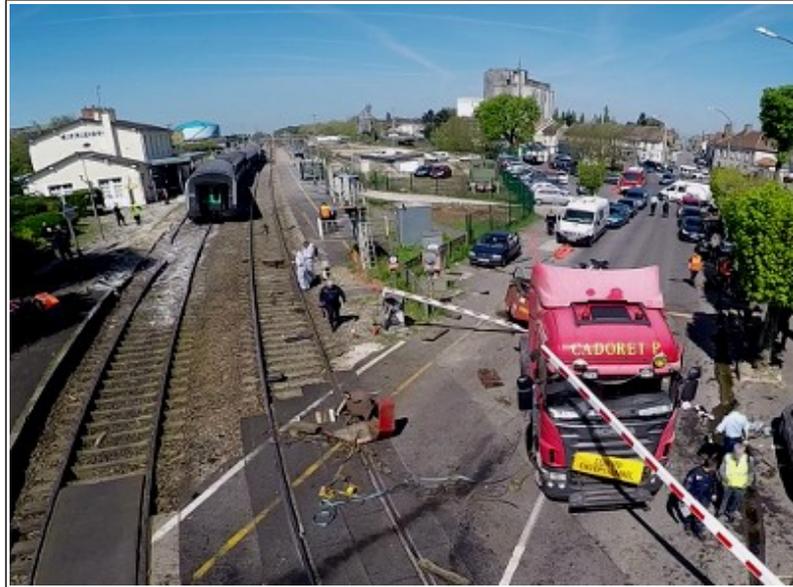
**Collision between a passenger train  
and a low-clearance lorry and trailer  
on 21 April 2015  
at LC No. 41 at Nangis (77)**

At about 08:40 on Tuesday, 21 April 2015, a passenger train connecting Belfort to Paris Est station collided with an abnormal load on a low-clearance half-trailer transporting agricultural equipment hauled by a road tractor unit on level crossing No. 41, located on departmental road No. 419 at Nangis in Seine-et-Marne.

This violent collision caused serious injuries to three people including the train driver and minor injuries to 40 others. It caused serious damage to the articulated lorry and to the rail equipment and infrastructure.

The direct and immediate cause of this accident was the fact that the abnormal low-clearance load was stuck on the level crossing.

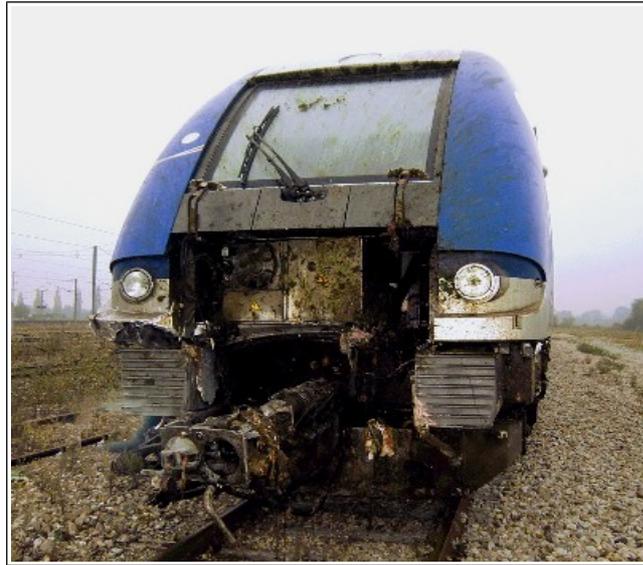
**Loss of control of regional express train No. 848973  
between Formerie (60), Serqueux (76) and Sommery (76)  
on 20 October 2015**

Before twilight at 07:35 on 20 October 2015, regional express train No. 848973 travelling between Abancourt (60) and Rouen (76) collided at full speed with two cows that had escaped from their enclosure after the station at Formerie.

After the impact, the driver realised that he was unable to stop his train, which went out of control at about 100 km/h going towards Serqueux.

Material damage was limited to the front face and underside of the train.

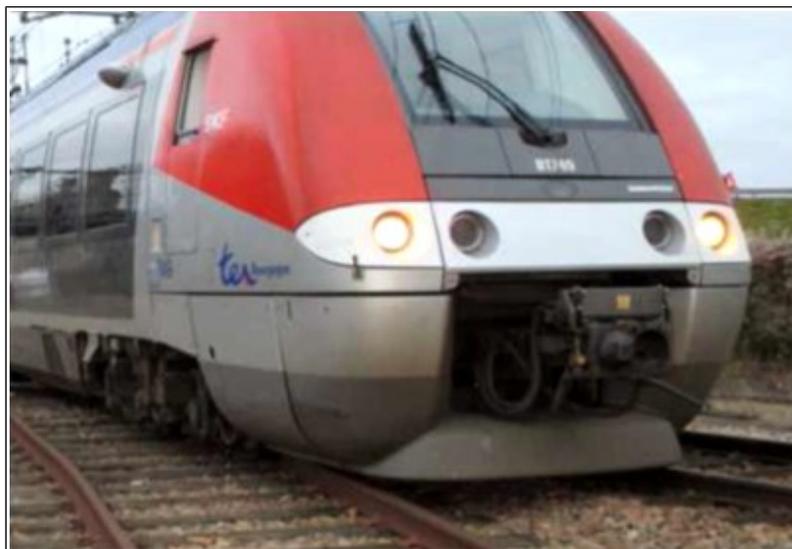
**Regional express train derailment  
due to trail through of points  
on 1 December 2015  
at the station at Laroche-Migennes (89)**

At 08:02 on 1 December 2015 in the station at Laroche-Migennes located in the municipality of Migennes in the Yonne, regional express train No. 891 350 travelling between Dijon and Auxerre-Saint-Gervais derailed at a speed of 20 km/h at switch points Tb on track A.

The direct cause of the accident was the fact that an earlier train had trailed through and damaged the Tb switch points.

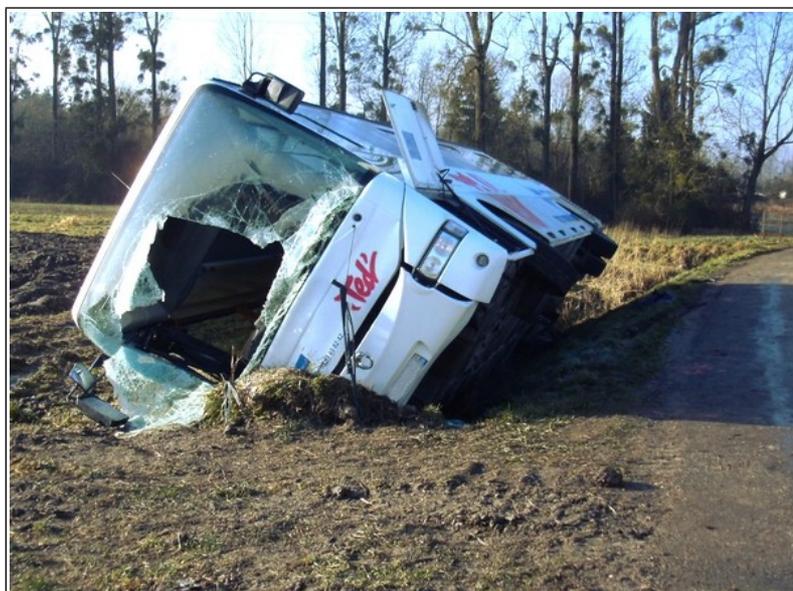
#### **School bus comes off departmental road 160 at Einville-au-Jard (54) on 3 February 2014**

At about 07:30 on 3 February 2014 at Einville-au-Jard in Meurthe-et-Moselle, a school bus came off the road at low speed on a bend and overturned in the ditch beside departmental road 160.

This accident cost the life of one school pupil and injured 18 others, including one seriously.

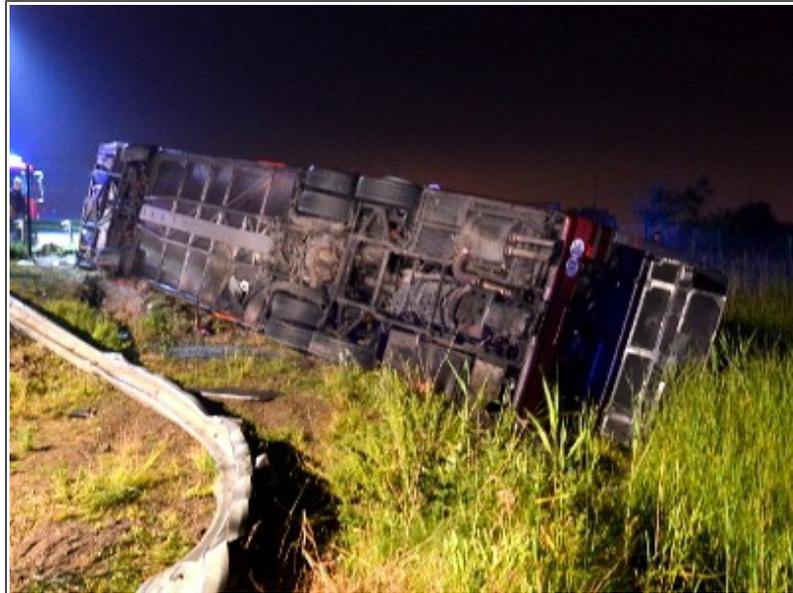
**Overturning of a coach  
on 9 June 2014  
on a roundabout on National Trunk Road 136  
at Loon-Plage (59)**

At about 21:20 9 June 2014, a coach travelling on National Trunk Road No. 316 going towards Gravelines with 51 passengers on board overturned on its right side at the exit of a roundabout in the municipality of Loon-Plage in the Nord department.

This accident cost the life of one passenger in the coach. 10 of its other occupants were injured, of which four were hospitalised for more than 24 hours.

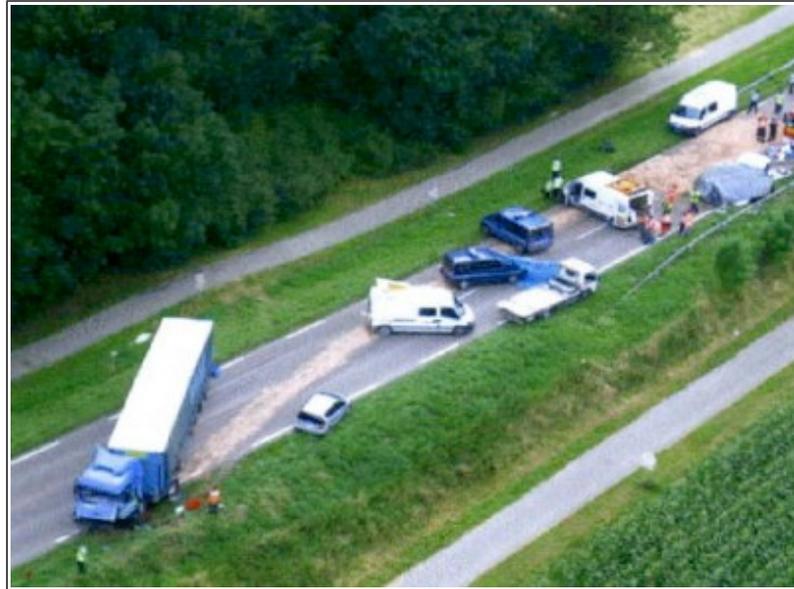
**Head-on collision  
between a minibus and a heavy goods vehicle  
on 22 July 2014  
on Departmental Road 169 at Courteranges (10)**

At about 14:40 on 22 July 2014 in the municipality of Courteranges in the Aube department (10), a minibus travelling on departmental road 619 going towards Troyes with nine people on board veered to the left and collided with an articulated lorry travelling in the opposite direction. After this initial impact, the lorry veered to the left and collided with a light vehicle travelling behind the minibus, then came to a halt across the road.

This accident cost the lives of six out of the nine occupants of the minibus and left four people injured: the three other occupants of the minibus, hospitalised for more than 24 hours, and the driver of the lorry who was lightly injured.

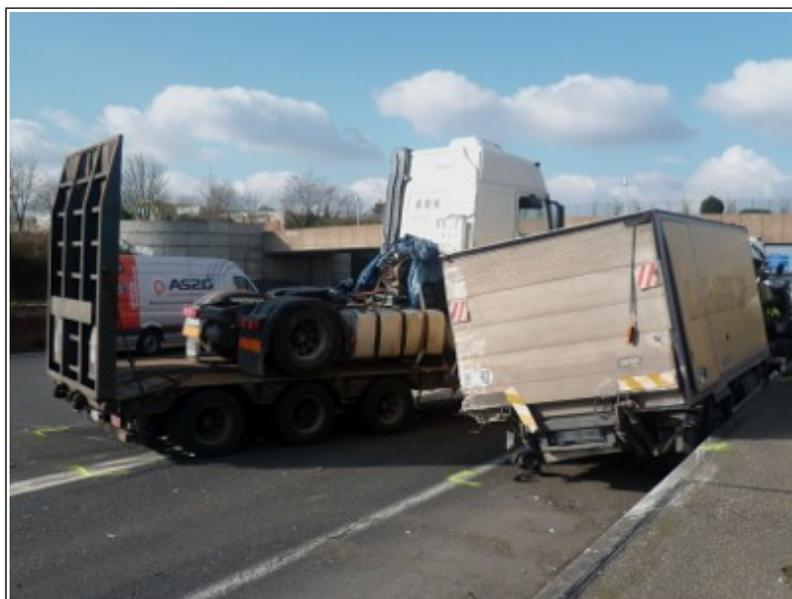
## **Pile-up on 5 February 2015 on the A6 motorway at Évry (91)**

At 12:09 on Thursday 5 February 2015 on the A6 motorway in the municipality of Évry, following a traffic slowdown, an articulated lorry consisting of a tractor unit and a half-trailer travelling towards Paris from the provinces collided with a light vehicle at the tail of a traffic jam, then with a lorry and finally with a van.

As a result of the collision, the two occupants of the light vehicle died.

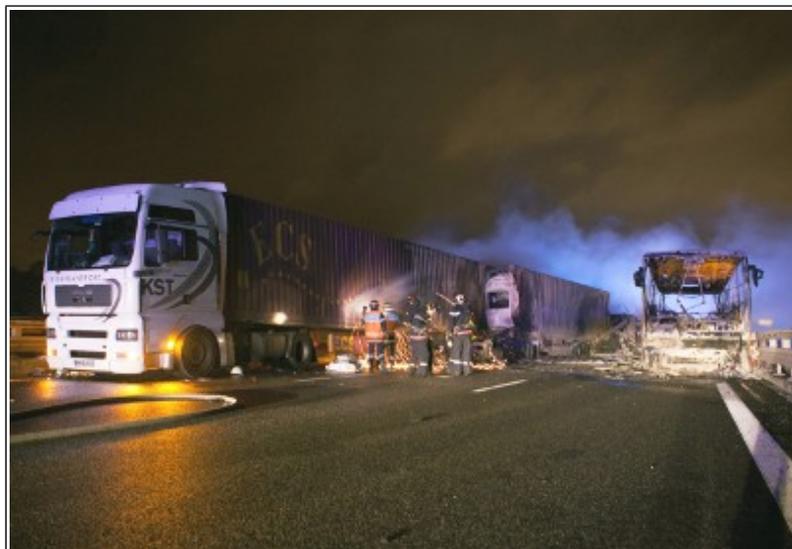
**Collision between three articulated lorries and two coaches  
followed by a fire  
on 13 February 2015  
on the A1 motorway at Roberval (60)**

At about 19:30 on the evening of Friday 13 February 2015, the day the holidays began, an accident involving three articulated lorries (tractor units with half-trailers) and two coaches occurred on the A1 motorway in the Lille to Paris direction on the Roberval viaduct (Oise).

The accident caused a major fire and the A1 motorway was blocked in both directions.

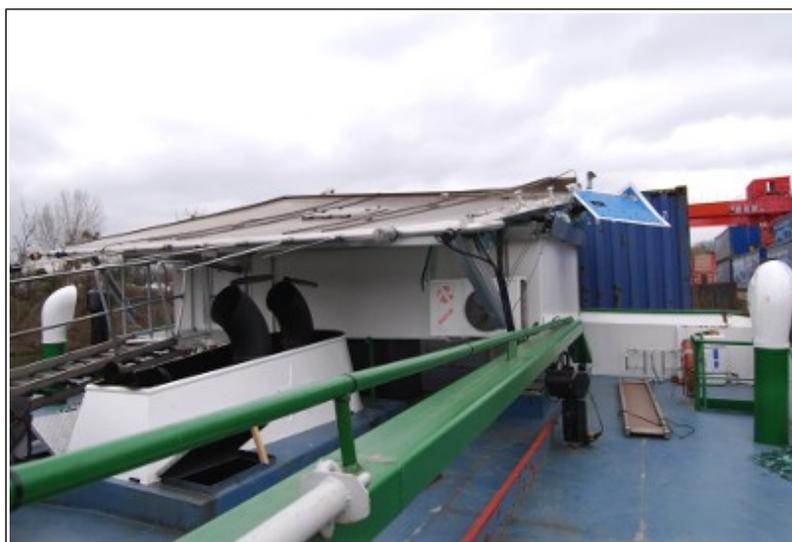
### Collisions between the MARFRET MARIVEL and the railway and road bridges at Bezons on 16 March 2012

At about 05:40 on Monday, 16 March 2012 on the River Seine at the upstream end of île Saint-Martin in the municipality of Bezons (Val-d'Oise), the MARFRET MARIVEL, the hull of a cargo vessel about 100 m in length, sailing from Rouen to Gennevilliers loaded with 465 tons of containers, collided several times with the base of the railway bridge pillars at Bezons. The vessel continued along its route and at about 05:52 its containers and its wheelhouse collided with the Bezons road bridge deck.

With the first impact against the pillars of the railway bridge at Bezons, a large hole was made in the hull of the boat at the forepeak<sup>2</sup>. The sheeting<sup>3</sup> at the base of one of the pillars of the Bezons railway bridge was damaged. The second impact damaged numerous containers and the telescopic wheelhouse of the vessel was crushed. The deck of the Bezons road bridge did not appear to be damaged.

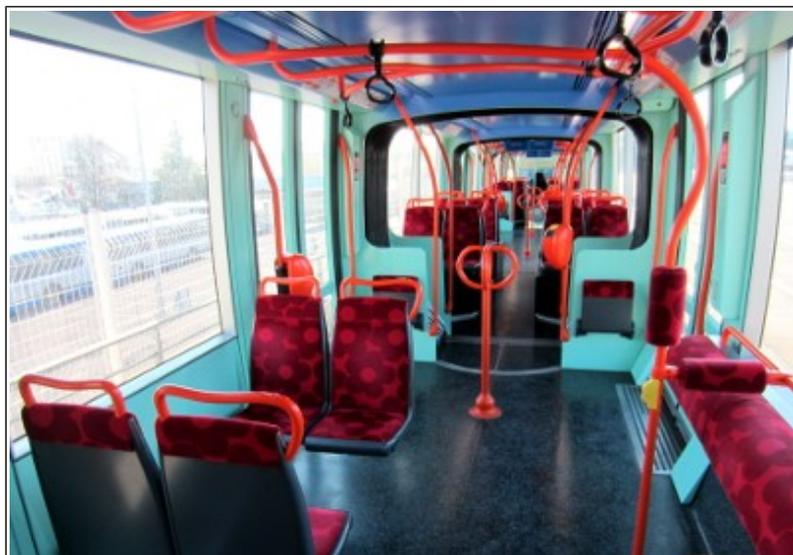
#### Fatal fall of a passenger in a tram resulting from an emergency stop on 3 September 2012 in Montpellier (34)

At 11:14 3 September 2012, tram No. 2095 travelling on Montpellier tram line 2 made an emergency stop between the “Comédie” and “Corum” stations that caused a 73 year-old passenger moving inside the tram to fall and hit his head violently on the lower part of a handrail. He died despite resuscitation attempts firstly by passengers, then by the emergency services after the tram was brought to the “Beaux-Arts” station.

The casualty fell as a direct result of the emergency braking triggered by the VACMA automatic vigilance system that the driver must activate regularly to confirm that he or she has not fallen ill or died, thereby not activating it within the prescribed time.

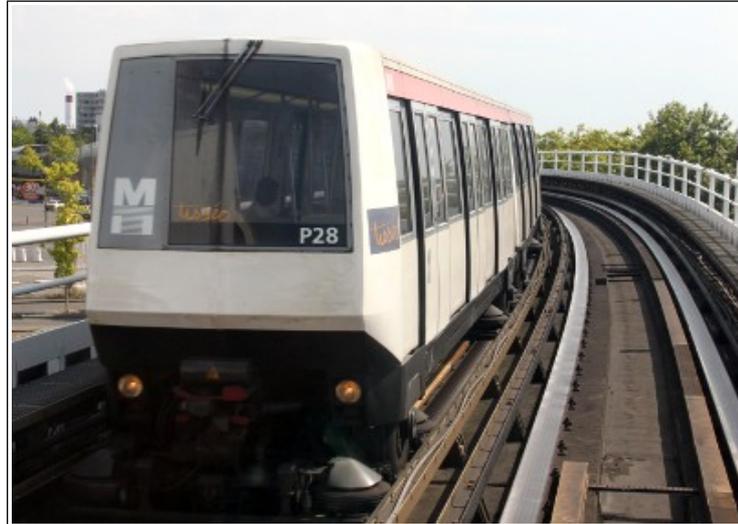
## Collision of two automatic Toulouse underground trains at "Bagatelle" station on 18 June 2013

At 18:33 on 18 June 2013 on line A of the automatic rubber-wheeled Toulouse underground station, following a thunderstorm, train 18 travelling at 10-15 km/h towards the "Balma-Gramont" terminus collided with stationary train 39 at "Bagatelle" station, causing minor injuries to 3 people.

Train 18 was applying normal service braking in advance in order to stop before the beginning of the section occupied by train 39. As it was not decelerating sufficiently, its automatic systems triggered emergency braking. It was then in the tunnel on a section of the track with a 7% gradient. Its wheels locked and it slid about 170 metres.
