Technical Investigation Report concerning the Fire on Eurotunnel Freight Shuttle 7412 on 11 september 2008

**Bureau d'enquêtes sur les
accidents de transport
terrestre**

**Rail Accident
Investigation Branch**

**Technical Investigation Report
concerning the Fire on
Eurotunnel Freight Shuttle 7412
on 11 September 2008**

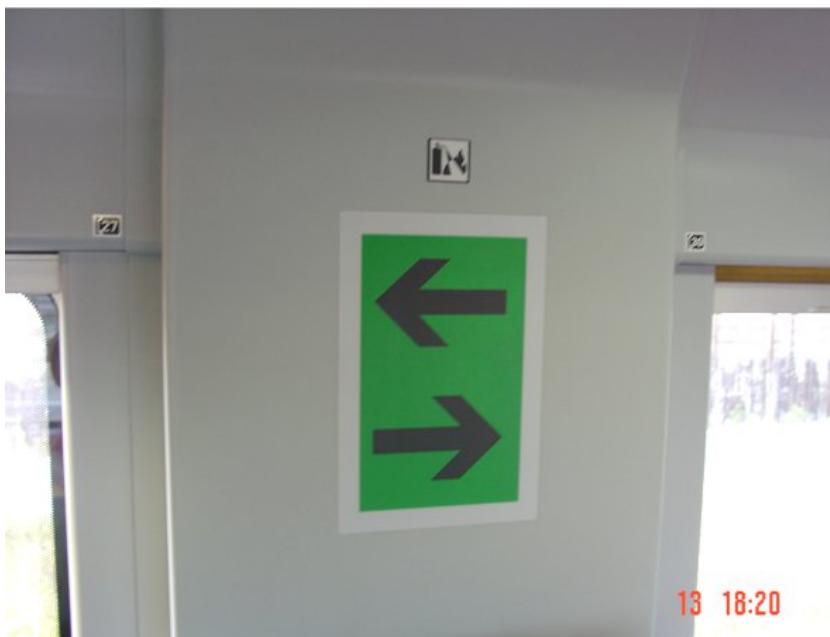
Figure 23: Amenity coach, evacuation, direction arrows

There are fixed markings to show the direction of the door but they do not indicate which door to use in the event of an emergency.

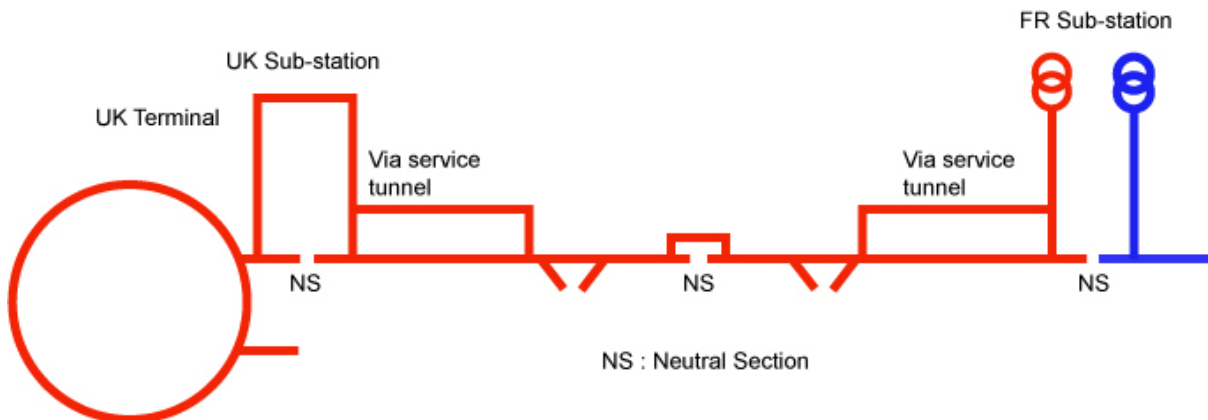
Figure 29: North Tunnel electric supply before the fire

On 11 September there was no breach of the catenary in Running Tunnel North, but there was a failure of the traction current 30 seconds after the train stopped.

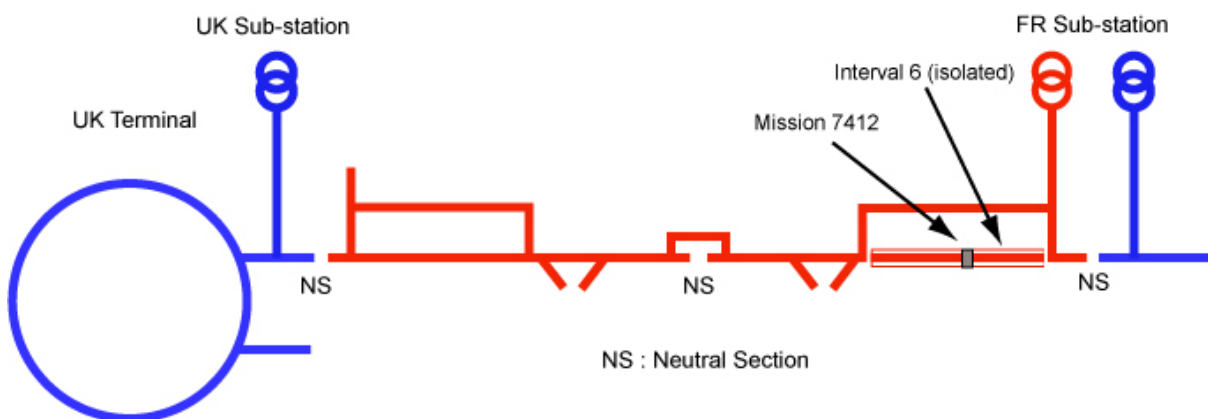
Figure 30: North Tunnel electric supply during evacuation of the two missions inside the tunnel

After the disconnection, no electricity is supplied to the whole of the North Tunnel. But there are trains inside the tunnel behind mission 7412. It is therefore necessary to restore the supply to the catenary so that the trains can be sent back to the UK.

- isolate the interval where mission 7412 is located (or at least a portion either side of the fire) and where the catenary has failed,
- re-supply the North Tunnel upstream of that interval and the UK terminal.

A little before 16:16 hrs, the catenary in the North Tunnel is reconfigured, i.e. supply is restored to the catenary on the UK side of interval 6.

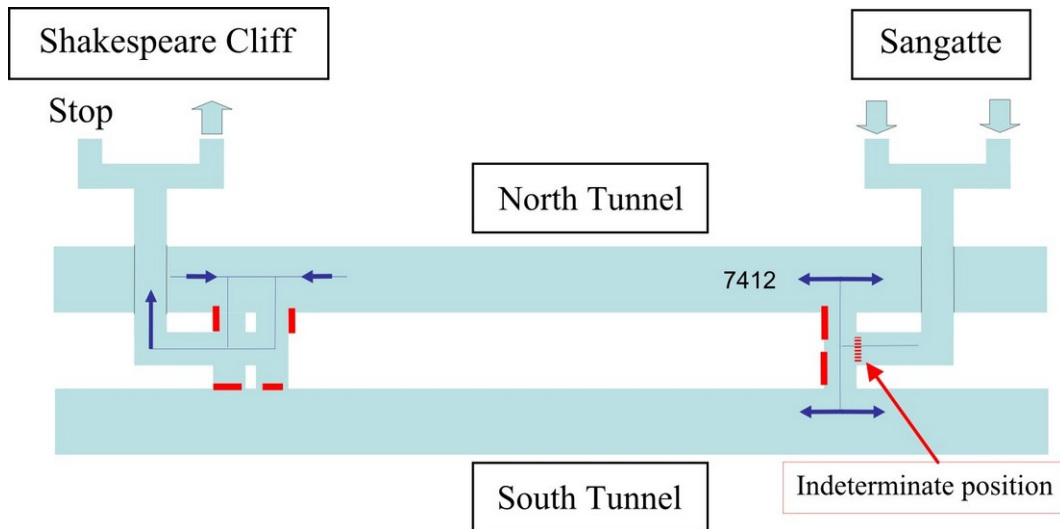
The controller first closes the dampers on the UK side, connecting the SVS to the South Tunnel. However, he stops one of the UK fans (at 16:07'53''). Between 16:07 and 16:09'17'' the situation is therefore as follows.

At 16:09'17'' a fan on the French side breaks down following the failure of the 21 kV cable. As the damper supplying the South Tunnel at Sangatte is still open, there is reduced air flow in the North tunnel.

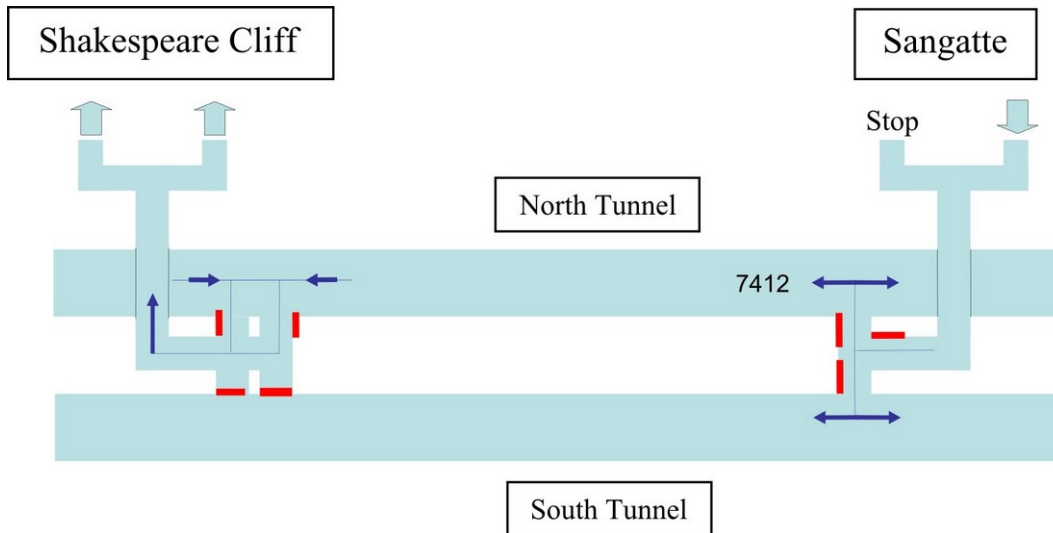
At 16:13 hrs, the second UK fan is started again by the EMS controller, increasing the air flow in the North Tunnel.

At about 16:26 hrs, the EMS controller realises that the French main damper malfunction message has disappeared. He then closes the damper for the Running Tunnel South, thus directing all of the air towards the North Tunnel. Although the SVS configuration on the French side is operating as it should, he keeps the UK SVS in Duplex mode, thus increasing the airflow in the North Tunnel. The configuration of the SVS is therefore still not compliant with Eurotunnel's rules for this scenario.

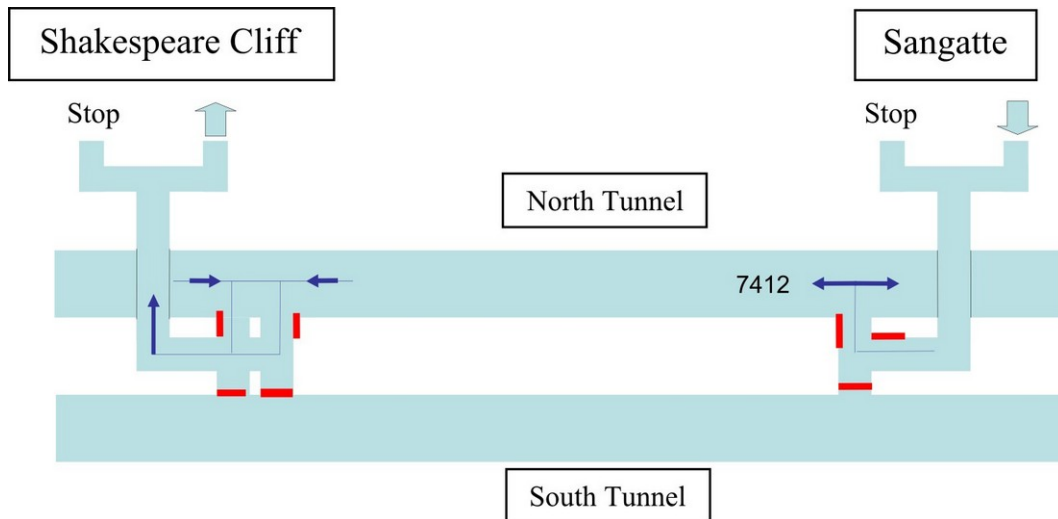
The above configuration is maintained for almost two hours. At 18:39 hrs, the EMS controller stops one of the UK fans. The SVS is now running according to the regulations. The situation is therefore as follows:

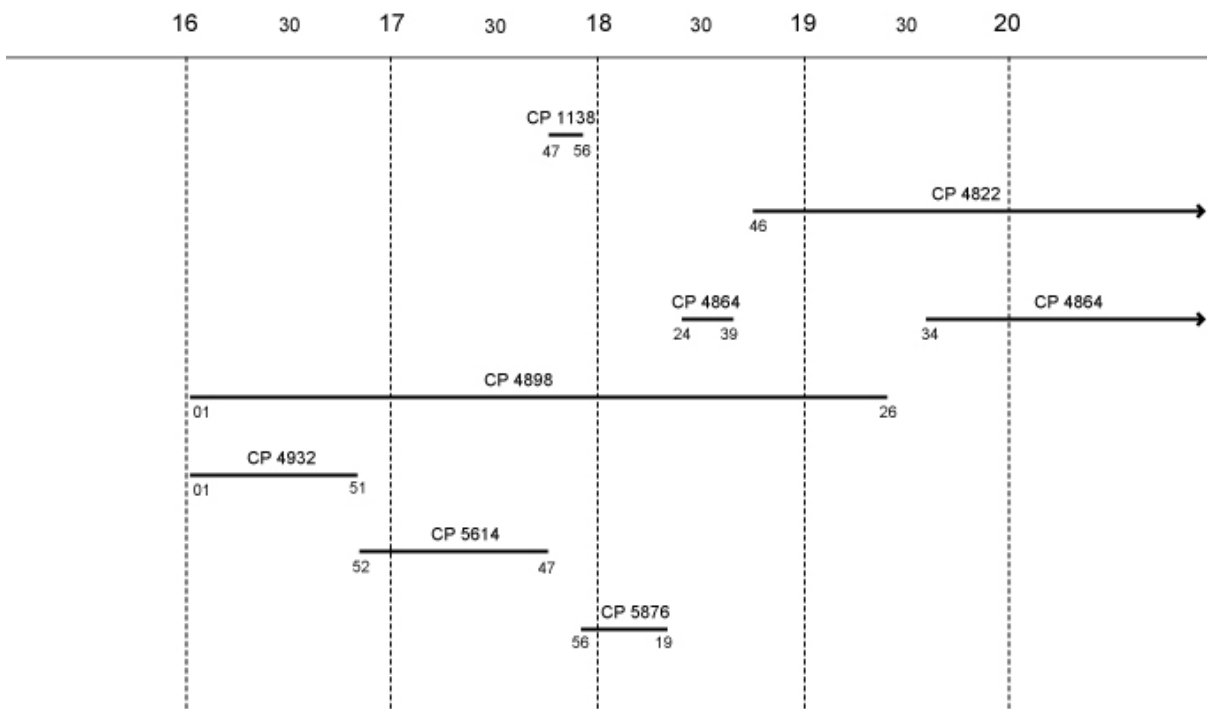
Figure 32: Opening of the cross-passage doors

The door of CP 4822 also had to be opened manually; with the exception of this control difficulty, the cross passage doors played their part.

The diagram below shows which doors were open between the start of the fire and 20:00 hrs and it can be seen that the rule of only having 2 doors open at the same time was observed.

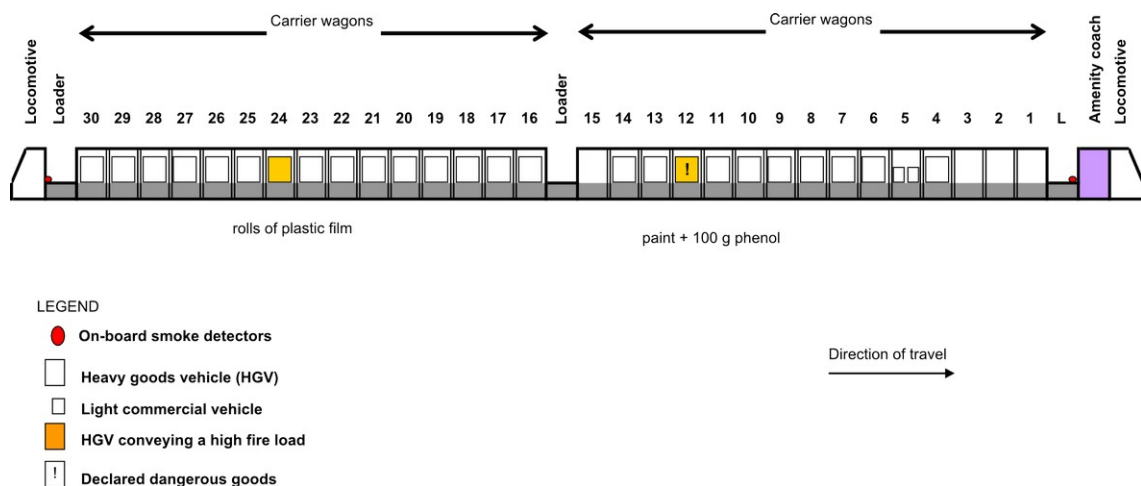
Figure 37: Composition and loading of mission 7412

Mission 7412 starts loading at about 15:20 hrs. A total of 27 freight vehicles are loaded (see Figure 37). One of the vehicles, carrying dangerous goods that had to be declared on arrival at the terminal (see Section 4.2.1), is now on wagon no. 12 instead of wagon no. 13. The loading information is not amended in the ISIS database.

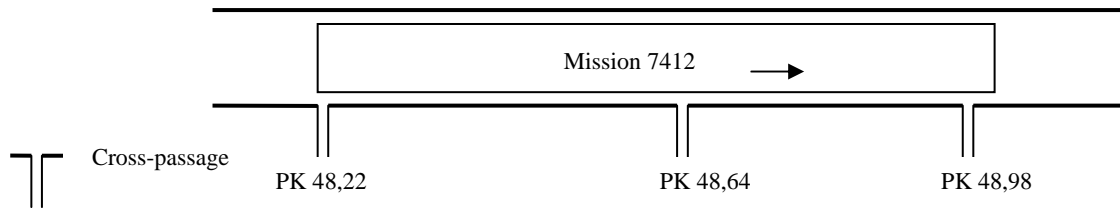
Figure 38: Position of the shuttle

At about 15:58'30'', the driver stops the shuttle in the position stipulated, with the driver's cab window beside the controlled stop marker. At this stopping point, he can see the marker indicating PK 49 but has not spotted the number of the cross-passage.

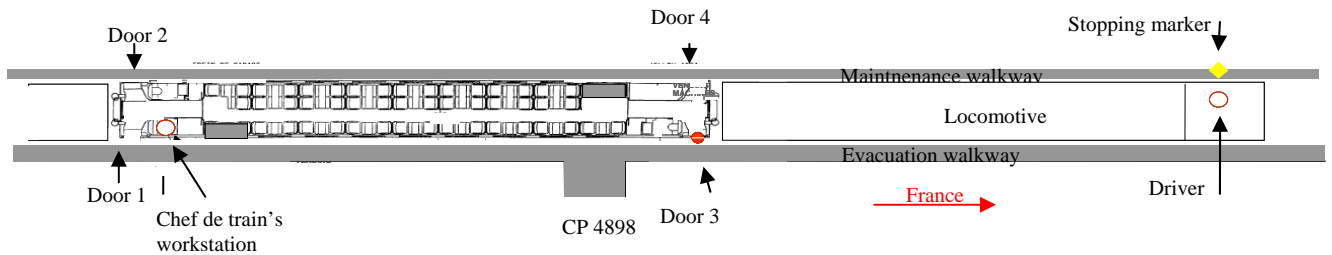
figure 39: Position of the amenity coach after shuttle 7412 has stopped

Although the chef de train has called to the passengers to follow him and leave the amenity coach through the rear right-hand door, they instead break the glass of the first window using a hammer provided for that purpose. The holes made by the hammer are not big enough for a person to pass through. One of the passengers kicks most of the remaining glass out of the window. It is approximately 16:03'30'', twenty-five passengers and the catering agent evacuate the amenity coach through this window in approximately two-and-a-half minutes. Some of them cut themselves on bits of glass still in the window frame and others suffer bruises when they fall onto the walkway.

The chef de train leaves the amenity coach through the rear right-hand door and heads for the cross-passage by walking along the evacuation walkway. None of the passengers follow him. After having covered 20 metres in the smoke he enters the area of fresh air around cross-passage 4898, at about 16:06 hrs. All the passengers who left through the window are already in the cross-passage or the service tunnel.

Also, the window beside the cross-passage is broken by the passengers and used by 25 passengers and the member of the catering staff.

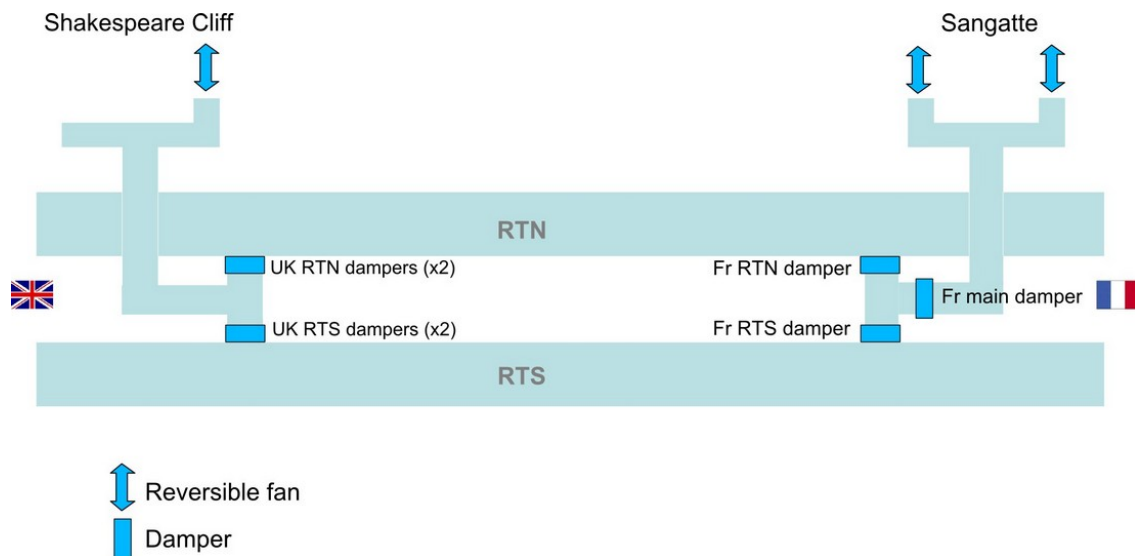
Figure 13 from paragraph 3.2.6.2)

At about 16:09 hrs, the loss of the 21 kV electricity supply causes one of the two fans in the SVS at Sangatte to stop. Furthermore, the main damper and the South damper at Sangatte are displaying malfunction messages.

As with the fault that occurred at 16:03'15'', the EMS controller has no information telling him whether the dampers have failed in the open or closed position. The controller does not have any procedure for situations of uncertainty regarding the condition of the fans or dampers.

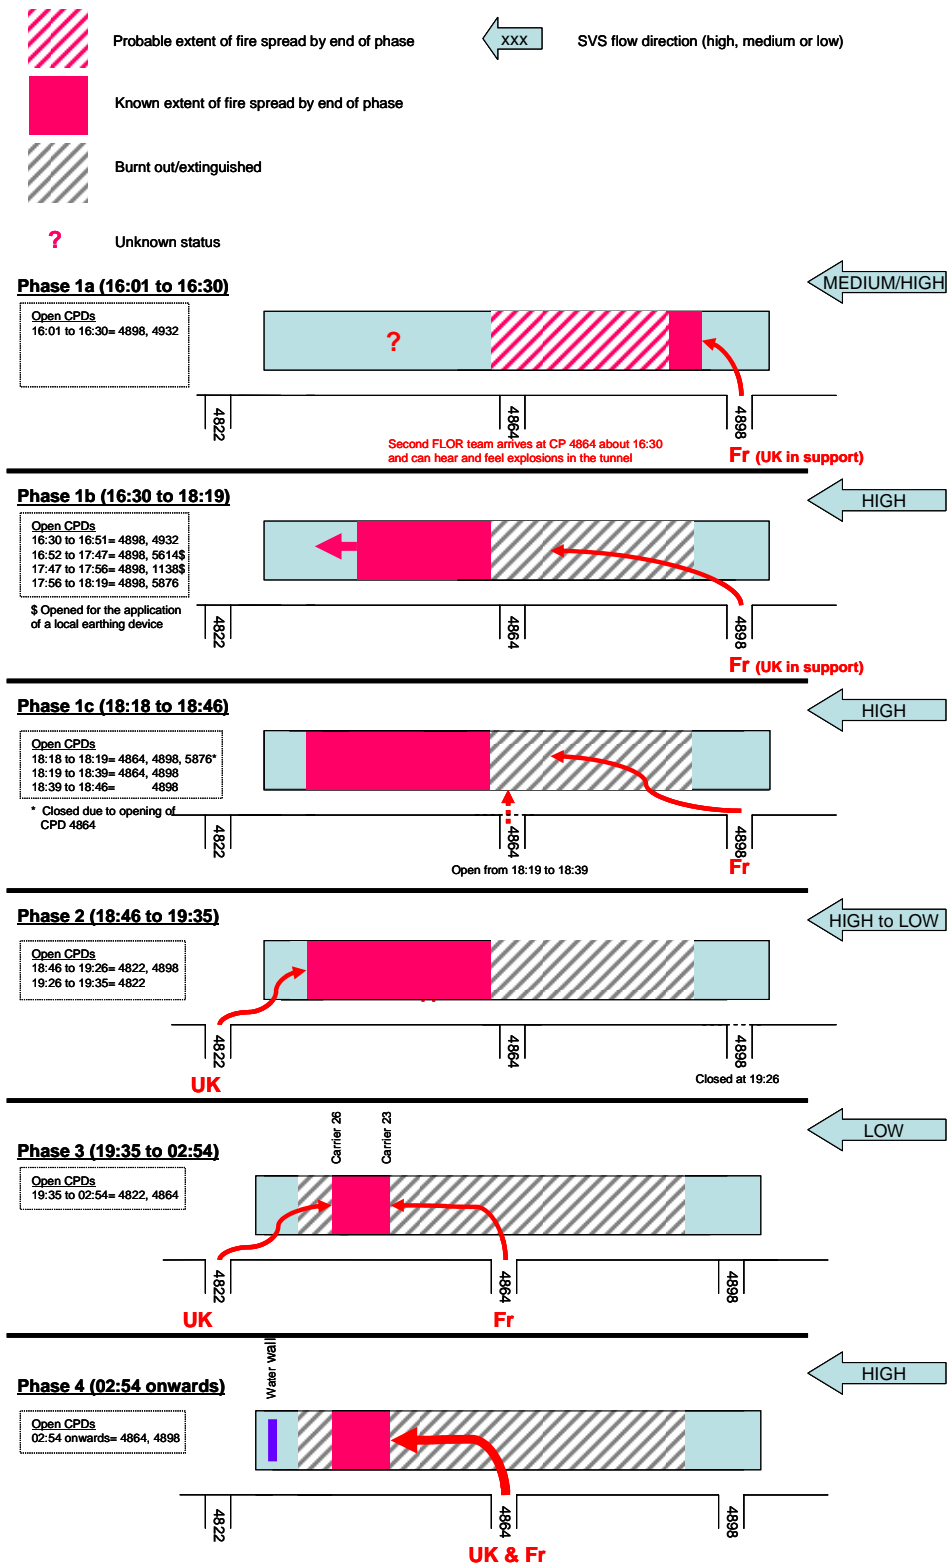
Figure 41: Overview of the fire-fighting operations

The sequence of fire-fighting operations is shown in Figure 41.

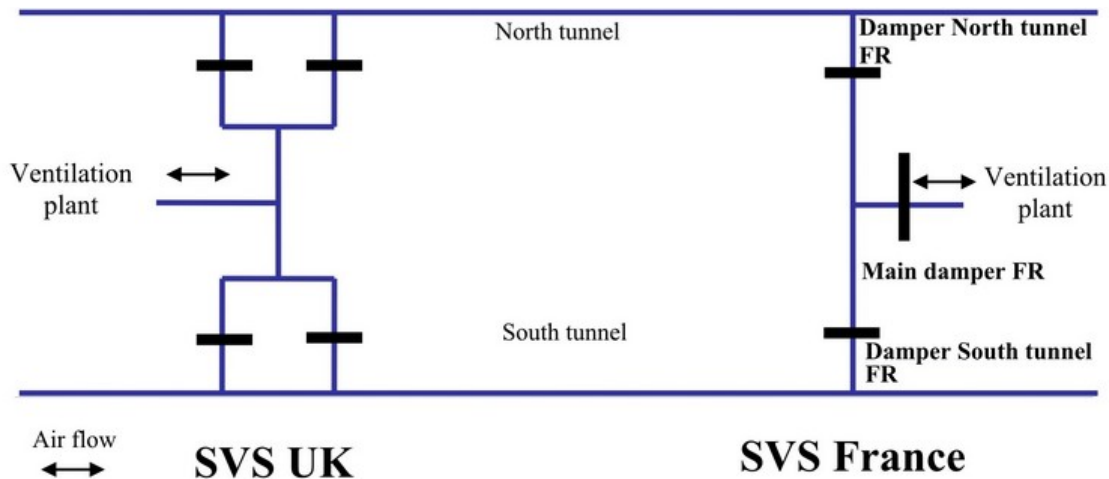
Figure 41: Ventilation dampers on the French and UK sides

The configuration of the supplementary ventilation system in the running tunnels is shown in the diagram above. This diagram shows that the malfunction of just one damper on the French side could mean that the operation of the French supplementary ventilation system

- *make the system less vulnerable (for example by moving the 21 kV feeders out of the running tunnels into the service tunnel where they are less likely to be subjected to a fire).*
- *facilitate the return to a normal or less disrupted situation (for example through the remote control of equipment so as not to depend on manual interventions).*
